Manhole Inspection Summary

Manhole # S33EE1017MH

Insp Date: **3/6/07 12:59 PM**

Location Address: **3800 39TH ST**

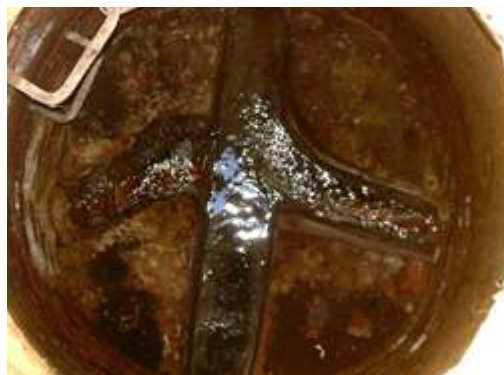
Top View

☐ Parged ☒ **Debris** (not Condition related)

Bench debris.

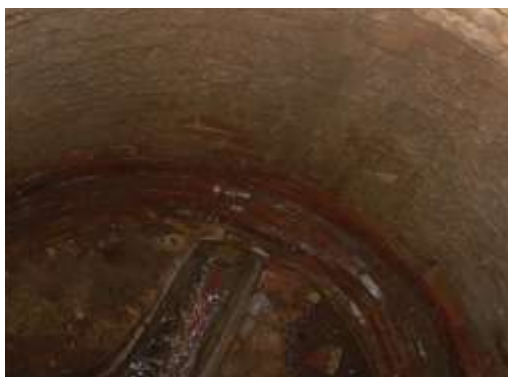
Defect

Infiltration: ☐ None ☒ **Joint** ☐ Cracks ☐ Mortar ☐ Roots ☒ **Wall**

Corbel infiltration.

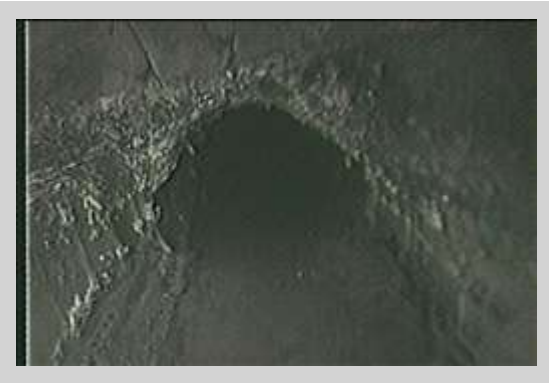
8 in. Circular Gravity Sewer Pipe Out @ 12 O'Clock

Deposits: ☒ None ☐ **Mud** ☐ Sludge ☐ Debris ☐ **Grease**

Infiltration: **None** Pipe Seal Cond: **Unknown**

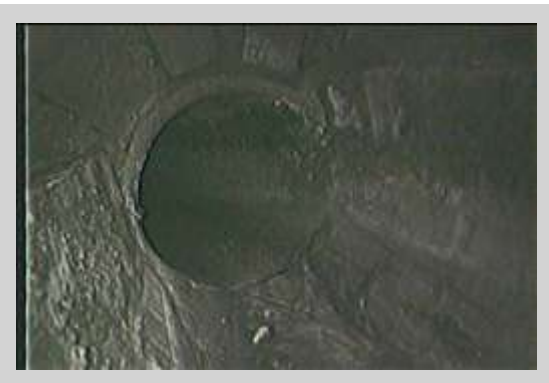
8 in. Circular Gravity Sewer Pipe In @ 3 O'Clock

Deposits: ☒ None ☐ **Mud** ☐ Sludge ☐ Debris ☐ **Grease**

Infiltration: **None** Pipe Seal Cond: **Unknown**

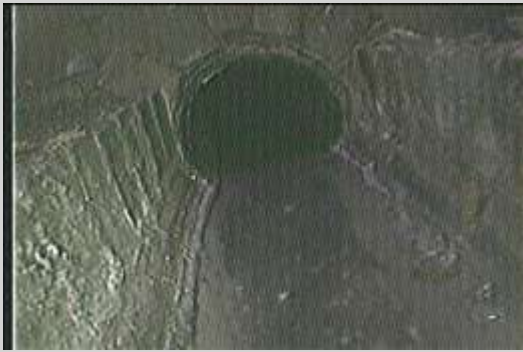
Pipe In @ 6 O'Clock

Deposits: ☐ None ☒ **Mud** ☐ Sludge ☐ **Debris** ☒ **Grease**

Silt Depth: **0** (in.) Deposits Extent: **Light**

Infiltration: **Evidence** Pipe Seal Cond: **Unknown**

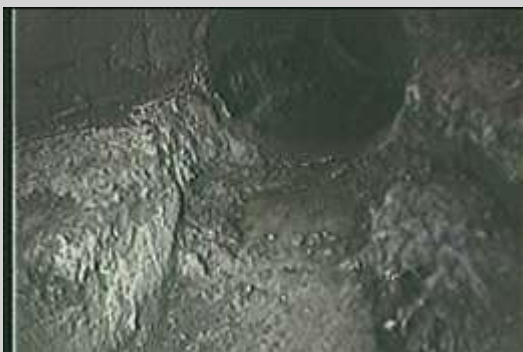
Pipe In @ 9 O'Clock

Deposits: ☐ None ☐ Mud ☐ Sludge ☒ **Debris** ☒ **Grease**

Silt Depth: **0** (in.) Deposits Extent: **Light**

Connects To: **Dead End**
